BASE EXTRUSION MODIFICATION AND LEAF SPRING INSTALLATION FOR REPLACEMENT FLEX FEEDERS

The flex feeder assembly is a highly stressed part of your luff system. Stresses can exceed design parameters when sail handling is done improperly. Forespar® has identified two reoccurring operator errors which result in flex feeders cracking at the transition point where the flex feeder extends below the support of the aluminum base extrusion. The following information will prevent breaking of flex feeders and instruction details for installing a replacement assembly. If you have any questions, please contact your Leisure Furl™ dealer or Forespar® at (949)858-8820.

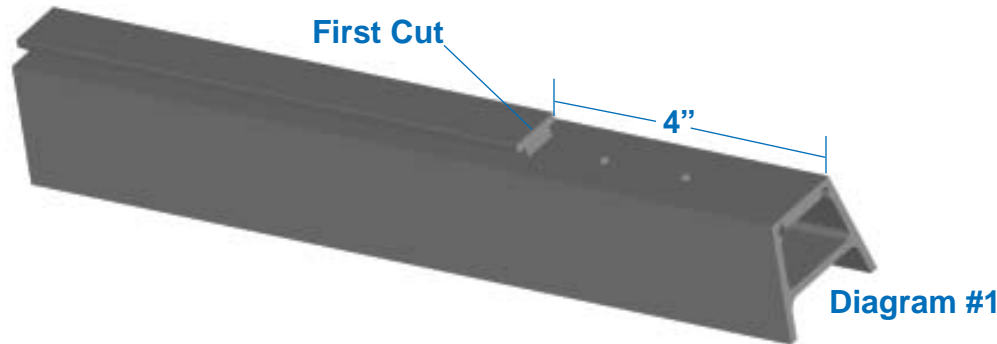
- 1) Measure up from the bottom of the aluminum base extrusion 4" and mark the top of the T portion of the aluminum base extrusion.
- 2) Using the hacksaw cut through the T portion (aft to forward). (Diagram #1)

- 3) Cut from the lower end of the aluminum base extrusion to remove the bottom 4" of the T shape. (Diagram #1)
- 4) Dress and fair the cut area of the Aluminum base extrusion using the file.

- 5) Place the leaf spring onto the aluminum base extrusion. Ensure it is straight and centered and mark the two fastener holes.
- 6) Drill the two holes and tap to 10-24. Now the lower end of your aluminum base extrusion should look like diagram #1.

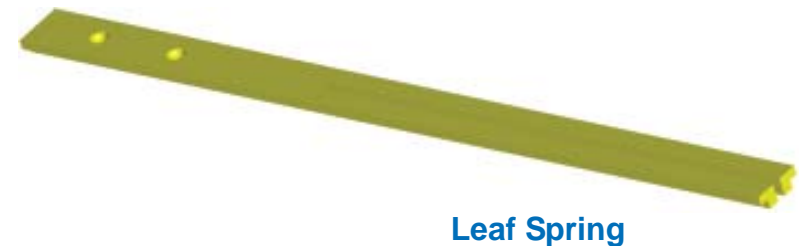
- 7) Attach the leaf spring to the aluminum base extrusion as shown using the supplied (2) 10-24 FHMS. (Diagram #2)
- 8) Slide the new flex feeder onto the leaf spring and aluminum base extrusion and replace the two screws to secure it.
